EVALUATION OF THE

750,000 Gallon Steel Elevated Water Tank

Brazil, Indiana

March 22, 2004

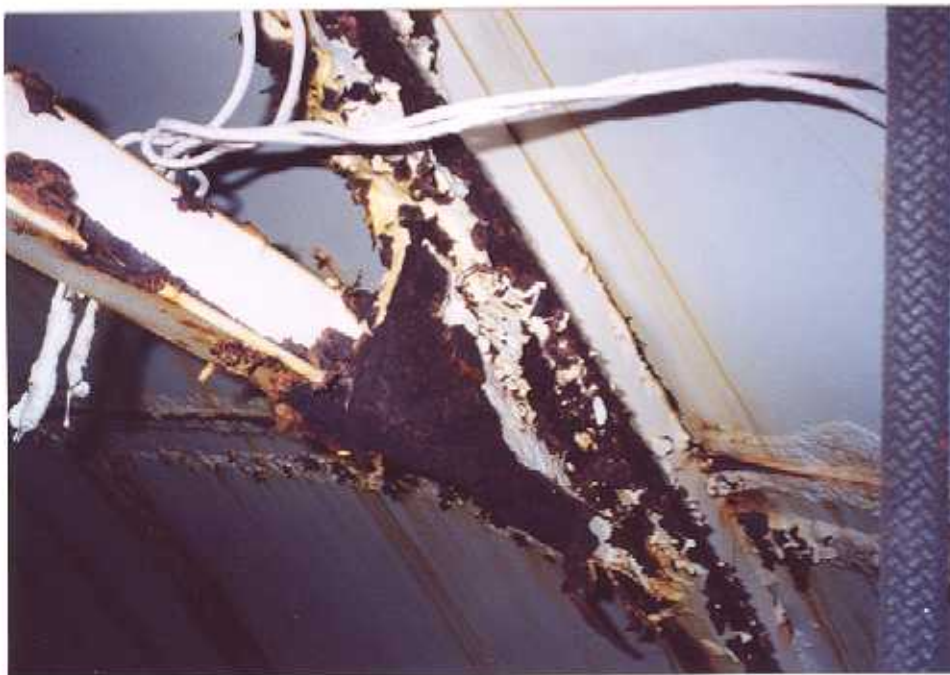
2. **Roof Condition:** The coating on the roof plates and roof structure appeared to be in very poor condition. The interior roof support structure consisted of radial roof trusses and intermittently welded stiffeners on the roof knuckle. The inner ends of the roof trusses were bolted to clips welded to a center hub. The outer ends of the roof trusses were bolted to plates welded to the roof knuckle stiffeners. Corrosion and metal loss were observed along the truss members and at the bolted connections. Wiring for a cathodic protection system was located in the roof of the tank. There were no anodes in the tank at the time of this field evaluation. (See photos 51-64)

58. Corrosion at connection of roof truss members.

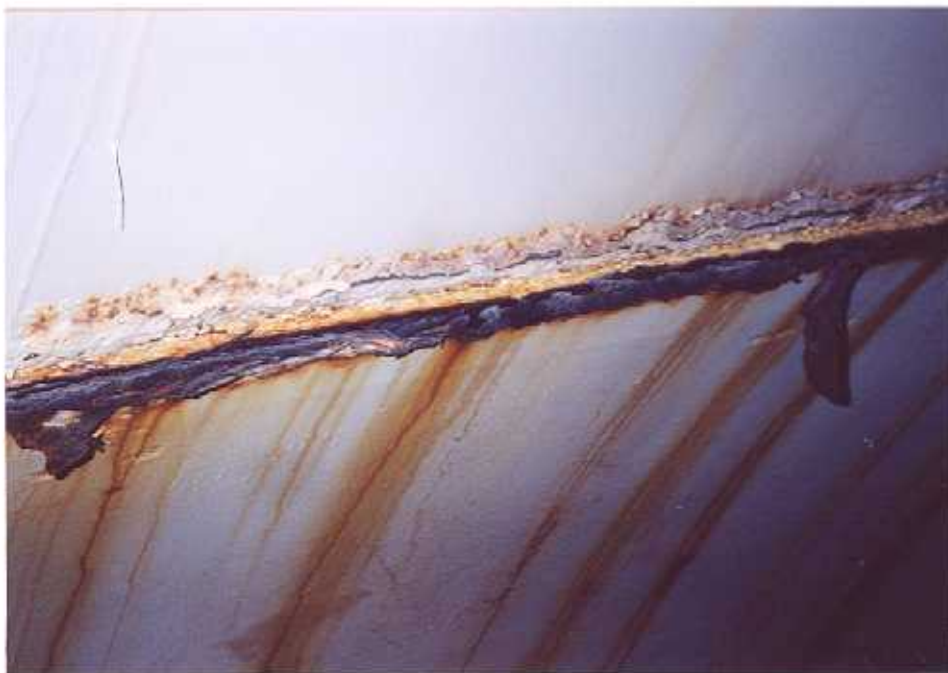
60. Corrosion along
lapped seam of roof
plates.

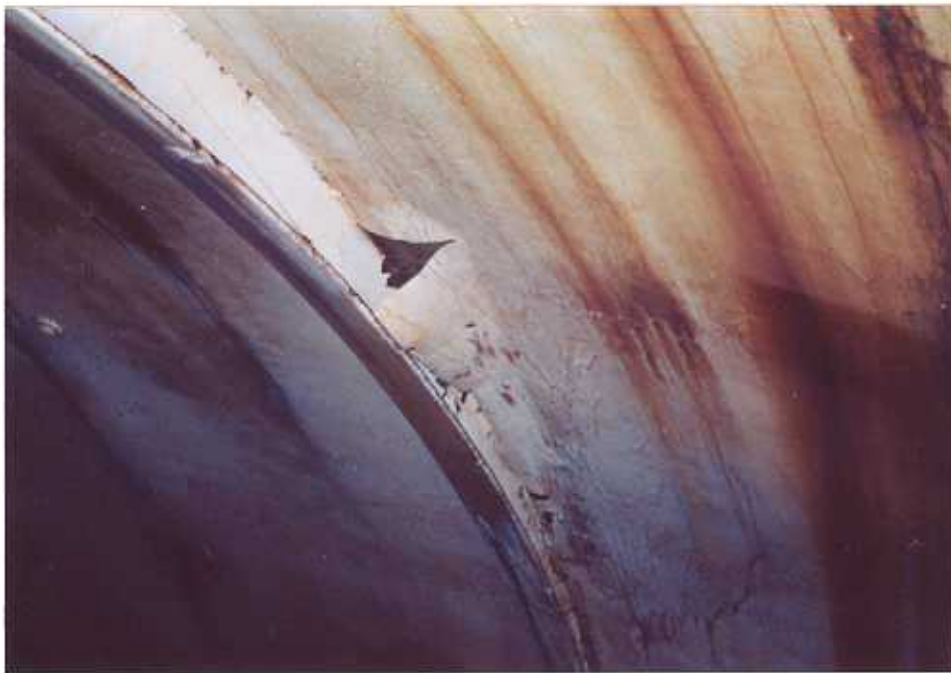
61. Peeled coating adjacent to roof stiffener.

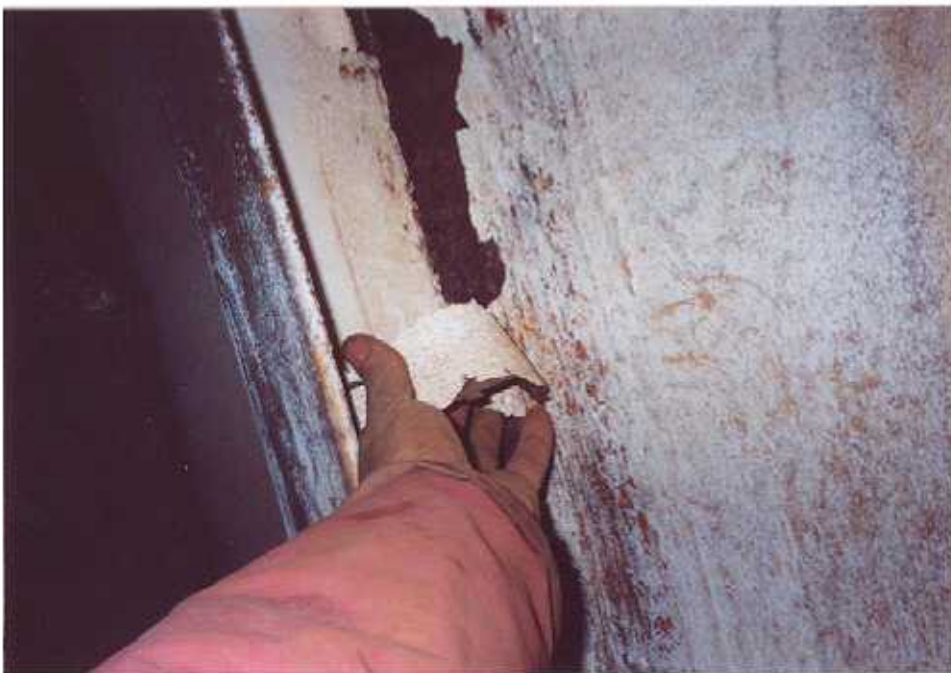
62. Peeled coating and rust adjacent to roof stiffener.

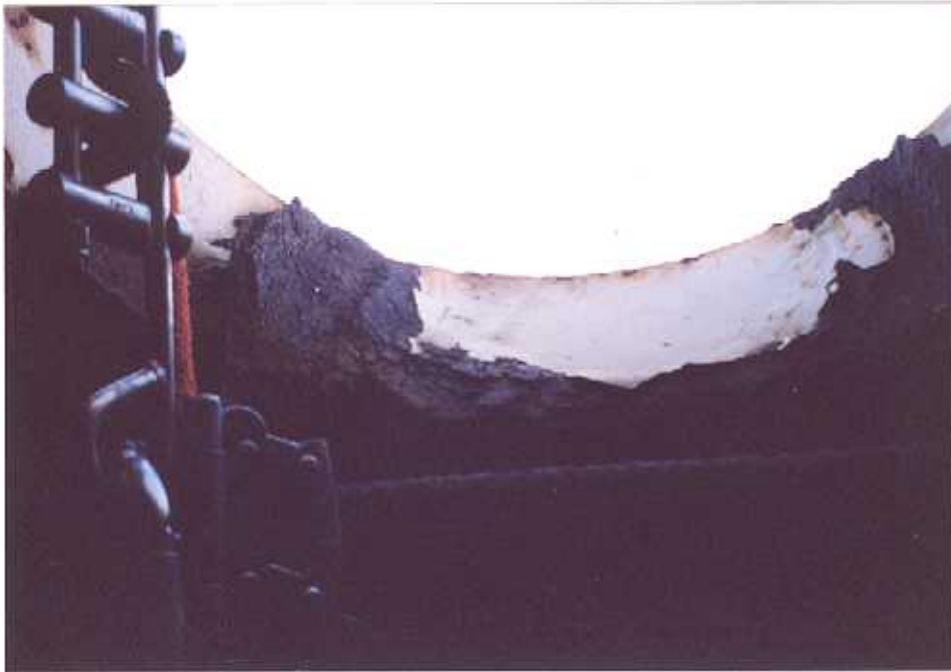
67. Corrosion on interior of roof manhole curb.

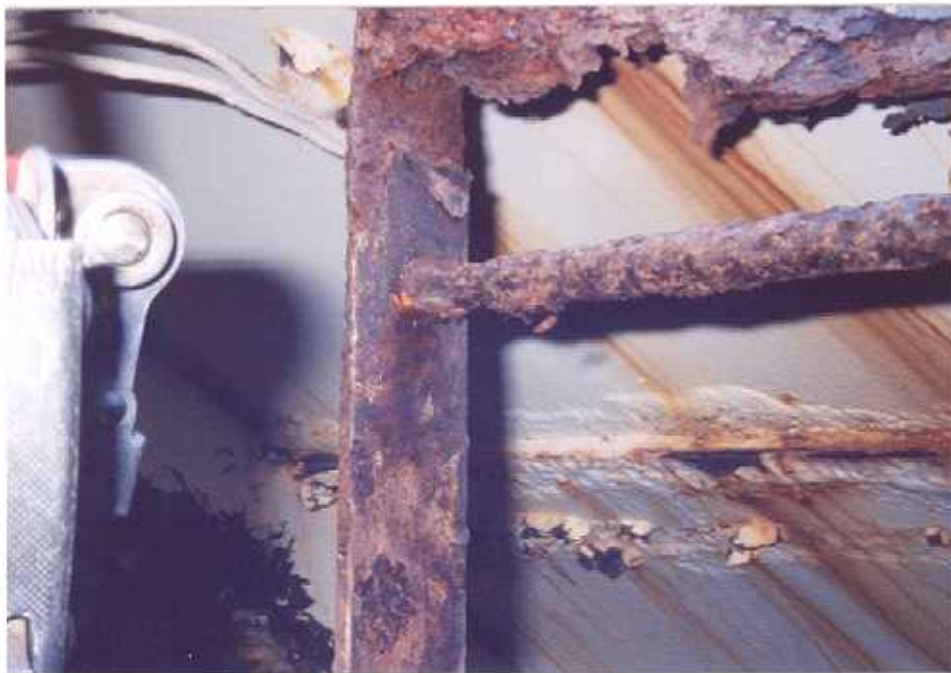
4. **Interior Container Ladder:** There were safety and OSHA deficiencies noted: (1) severe corrosion and metal loss were observed on the ladder brackets and rungs, (2) the ladder was not equipped with a safe-climbing device, (3) the width between side rails of 15-3/4 in. did not meet the required 16 in. minimum, (4) the 22 in. head clearance at the roof manhole did not meet the required 30 in. minimum, (5) the 2 in. x 1/4 in. side rails did not meet the required minimum of 2-1/2 in. x 3/8 in. side rails, (6) the 5/8 in. diameter ladder rungs did not meet the required minimum ladder rung diameter of 3/4 in., and (7) the rungs were not of a slip-resistant

design. The interior container ladder was welded to brackets which were welded to the shell. The interior container ladder and brackets appeared to be in poor structural condition at the time of this field evaluation. Each set of ladder brackets had one diagonal support. Significant metal loss and holes were observed in the bottom set of brackets. The top rungs of the ladder had experienced metal loss up to half the diameter of the rung. **Due to the significant corrosion and metal loss on the existing interior container ladder, personnel should not use the existing interior container ladder for access.** (See photos 68-71)

68. Corrosion and metal loss on interior container ladder below roof manhole.

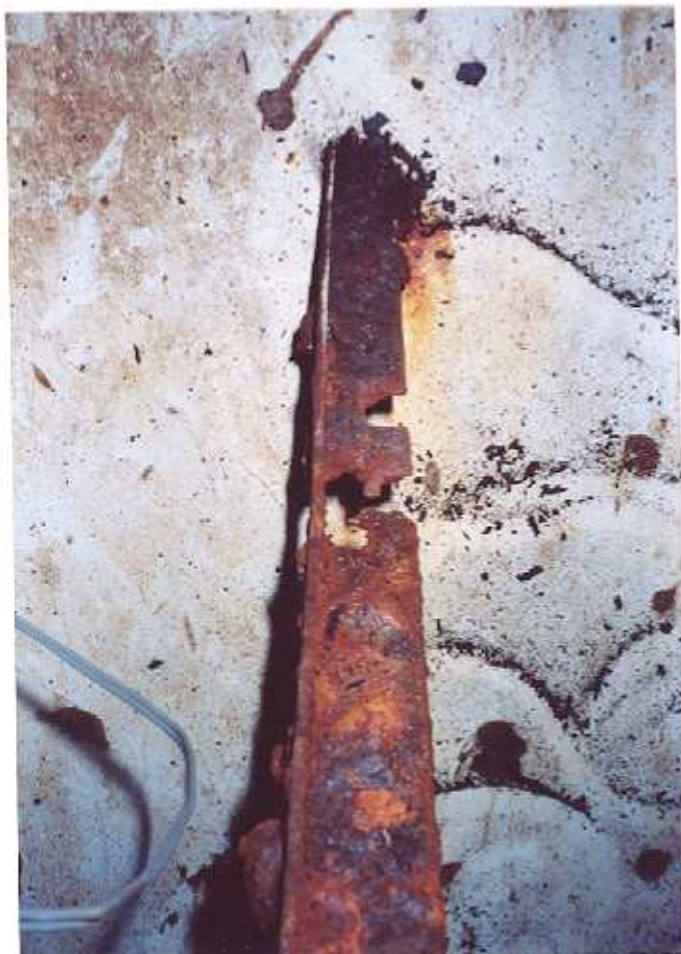
70. Corrosion and metal loss on interior container ladder at bowl.

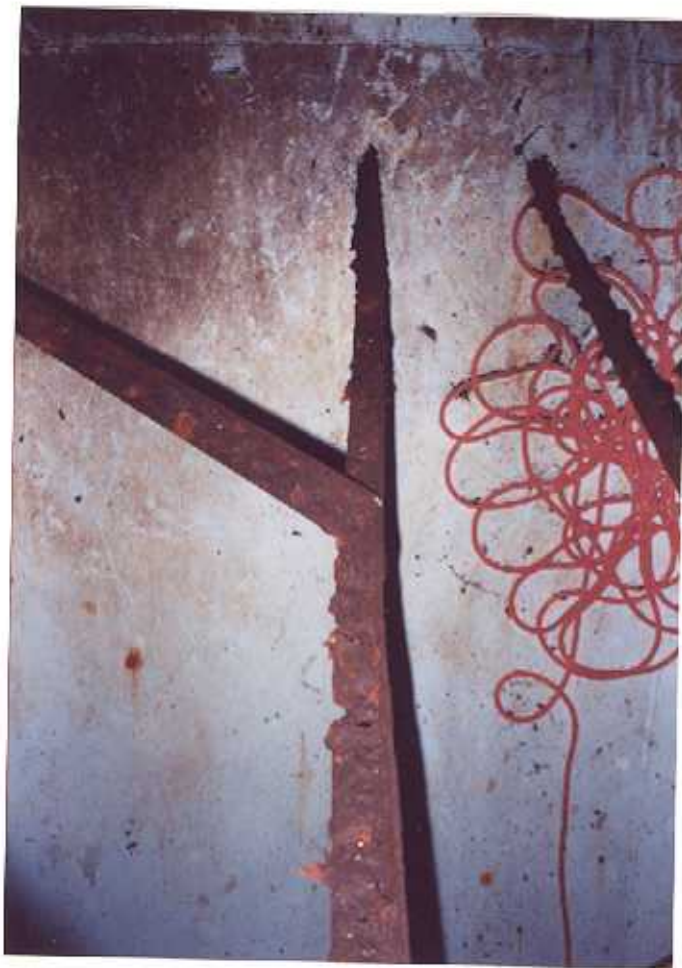
- 71. Corrosion and metal loss on interior container ladder at bowl.

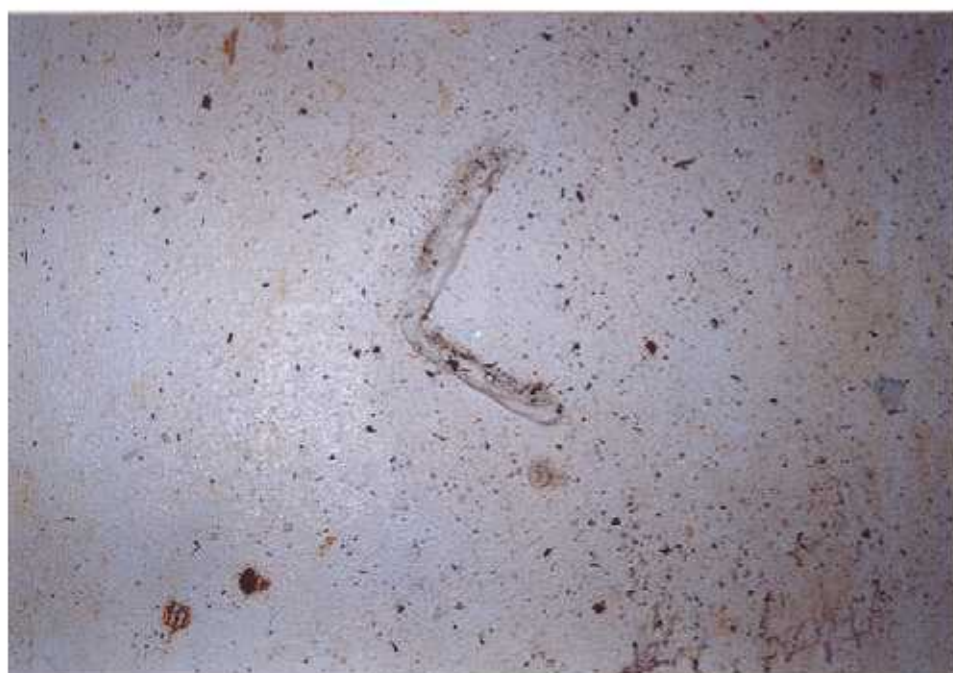
6. **Bowl Condition:** Isolated coating failures on the bowl in the area of the riser-to-bowl connection had allowed significant pitting to occur. The spot coating failures had resulted in pit depths of up to 13/32 in. A random cluster of blisters was noted on the interior bowl. The coating on the rest of the bowl appeared to be in generally fair condition. A hinged safety grate was located over the riser opening in the bowl. (See photos 72-83)

74. Weld burrs on interior bowl.

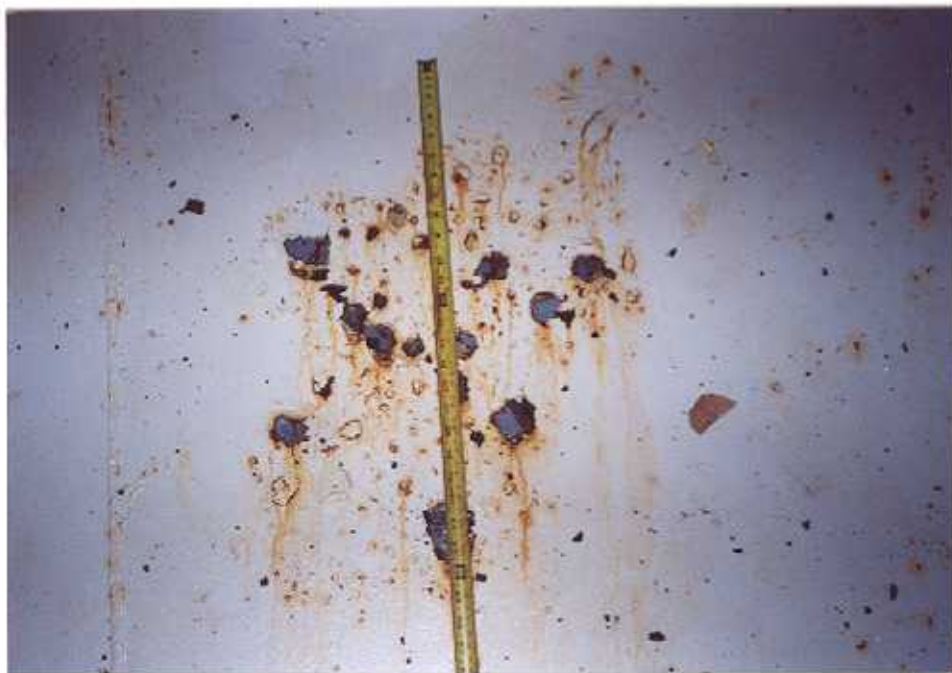
76. Coating failures on bowl.

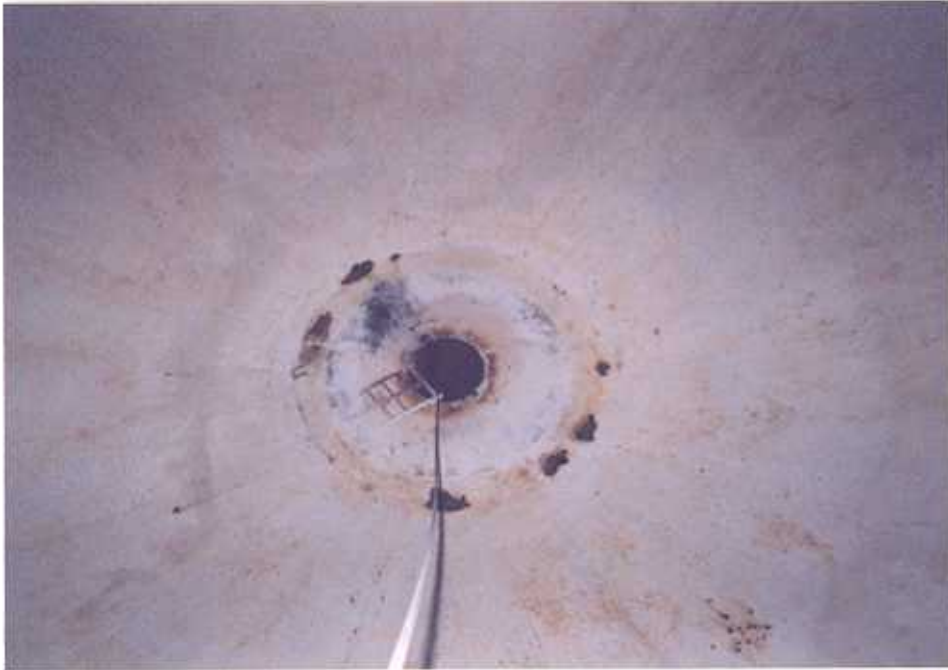
77. Interior bowl and riser opening with safety grate. Note pitted areas on bowl around riser opening.

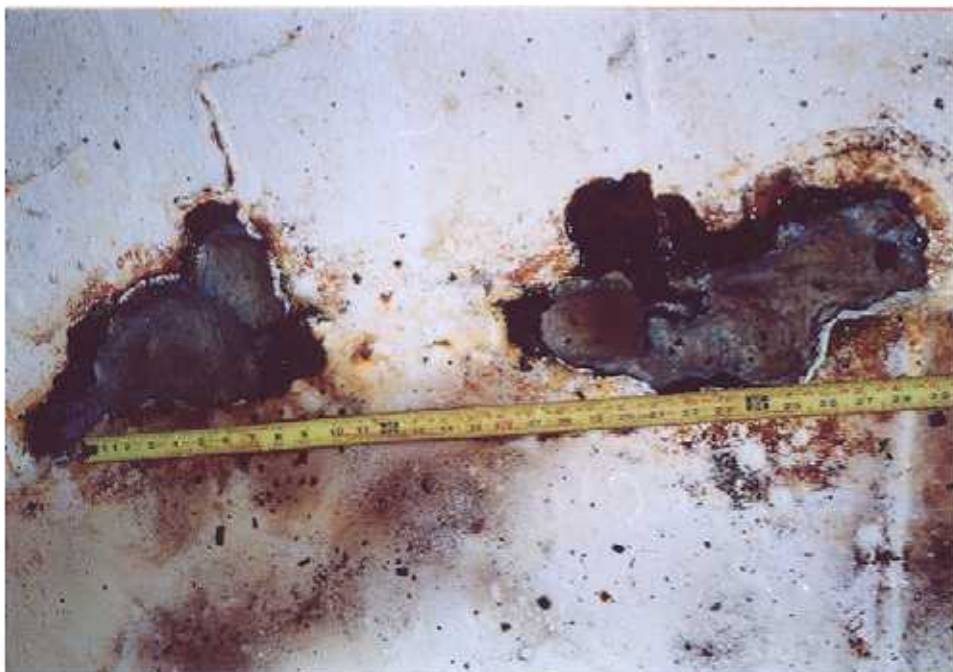
80. Pits in bowl.

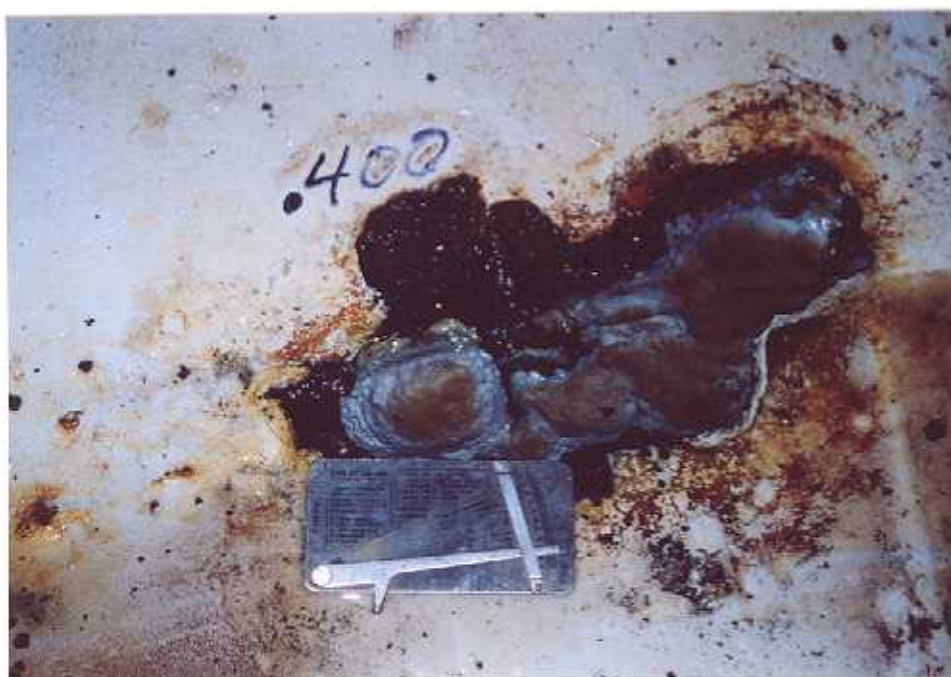
82. Pits in bowl.

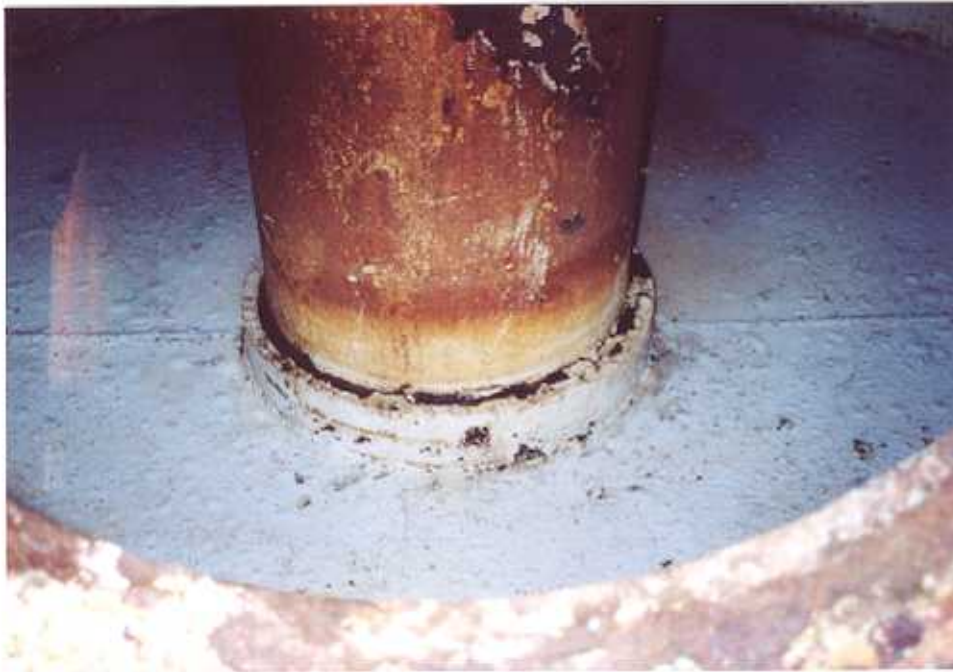
7. **Riser Condition:** The coating on the interior of the riser cans appeared to be in generally fair condition. Random pinhole rust was noted in the riser. Significant blistering was observed in the coating on the floor of the riser. Brackets and lugs were located inside the riser and at the floor of the riser. **It is the opinion of Tank Industry Consultants that the lugs and brackets in the riser should not be used for rigging purposes or personnel access.** (See photos 83-90)

88. Blisters in coating on riser floor.
